# **2018 Douma Incident in Syria: Chemical Weapons Attack or Concealed Mass Murder?**

**A Critical Evaluation of OPCW Reports and Available Evidence**

**A Report by Adam John Larson  
Monitor on Massacre Marketing / A Closer Look On Syria  
Working Group on Syria, Propaganda and Media  
January 25, 2026**

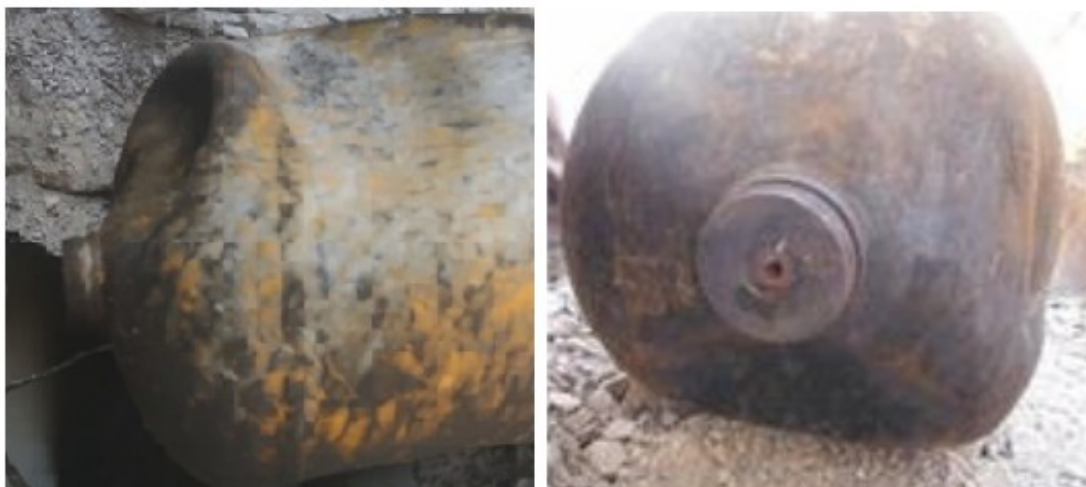
At Douma's Location 2, in contrast, the EST report noted “the front of the observed cylinder shows no signs of impact with the concrete slab or rebar, and the appearance of the observed rebar does not

indicate it having slowed the cylinder to a stop." <sup>43</sup> We see a missing valve and some mild buckling near the front, but no sign of flattening, no indentation, and no ruptures. The alleged circumstances are different than in the above case, but probably not different enough to explain the discrepancy. As such, the evidence suggests **the vessel suffered its minor damage in some other way before it was set here next to this preexisting crater.** <sup>44</sup>

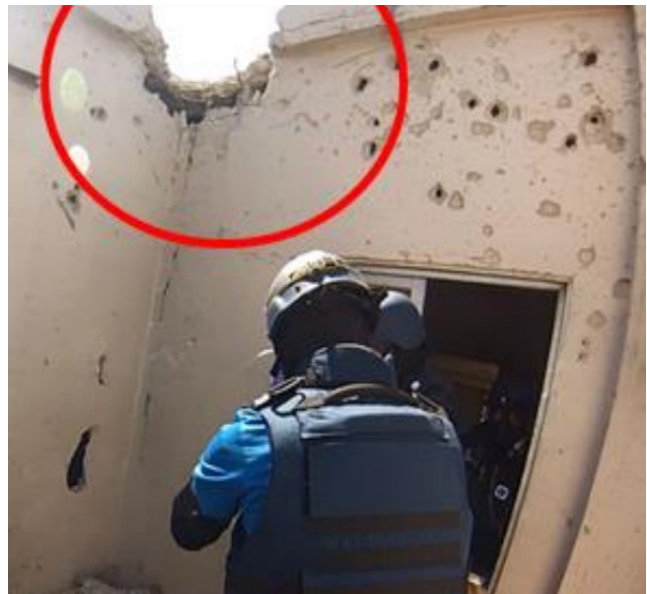
One of the FFM's experts was cited with "an explanation of the cylinder not penetrating completely through the aperture" at L2. They noted "a large impact on the roof and walls above the balcony" at the southeast corner, where the cylinder may have first hit, slowing it to impact the floor “without sufficient energy to fall through” the hole it was able to create.<sup>50</sup>

At right is a cropped image from the report, with their circle on the possible first impact point, with the cylinder and crater below.<sup>51</sup> Just outside that circle is a band of obvious primary fragmentation or “shrapnel” marks, which continues on other walls, suggesting an artillery shell, most likely from a light mortar, impacted here. To the IIT in 2023, those marks were a clear “fragmentation pattern”<sup>52</sup> and it was by then “unclear” whether the cylinder impacted here.<sup>53</sup> It would be quite a coincidence for it to hit the same spot an artillery shell had impacted, hiding its own damage with this visual ambiguity.

The FFM final report also noted "an explosive device ... is unlikely given the absence of primary and secondary fragmentation characteristic of an explosion *that may have created the crater.*"<sup>54</sup> (emphasis added) It may be worth laboring this point to settle some widespread confusion. First, primary marks are from metal fragments or “shrapnel” loaded in the weapon, while secondary marks are from external materials, like concrete, energized by the blast. Next, the EST report probably referred to the marks seen above as "an (unusually elevated, but possible) fragmentation pattern on upper walls," suggesting it was caused by a detonation at the balcony floor. The FFM didn't deny the marks. They just don't link them to the floor crater. The author agrees they seem too “elevated” for that, and probably link to that corner damage instead. The IIT likewise noted the lack of such marks near the crater, on the lower walls, and that the shrapnel damage above is “inconsistent with an

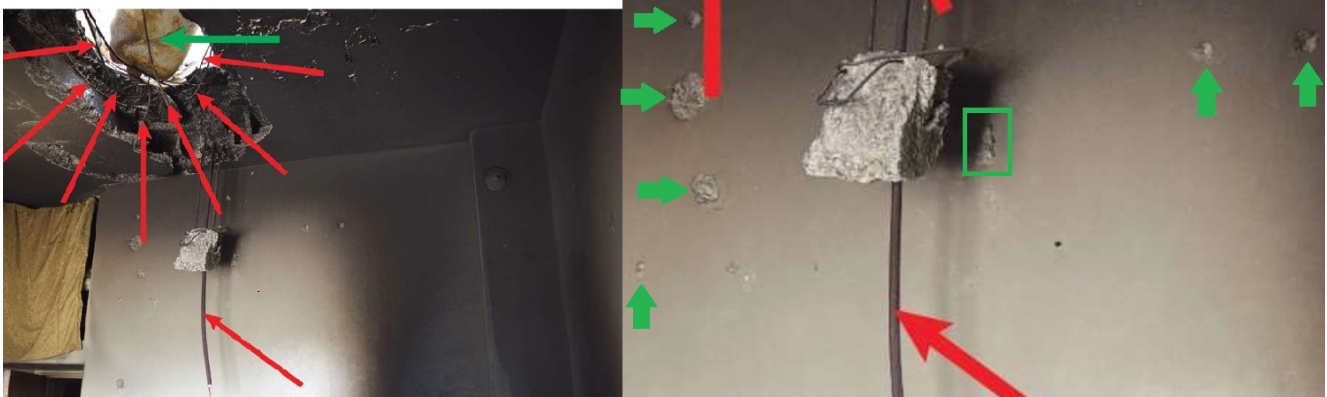
But the IIT report also says, in the caption for figure 11, "no fragmentation damage pattern consistent with explosion is visible on the walls" of *the room beneath the crater* (below, left).<sup>55</sup> This is not the main place to look, and the claim seems to be false. They have 8 arrows pointed at the cylinder, for some reason, and none at the dozens of chips and indentations across the upper walls they were actively denying (and it's possible the EST report was referring to these "elevated" marks). The walls to the left and right seem to be marked as well, but the clearest damage is in the view below, detail at right: 8 clear chips marked with green arrows, with perhaps dozens of faint dents in between, now obscured by soot. These seem to be **secondary fragmentation marks**, from concrete broken to bits and propelled almost sideways by a radial blast wave. One larger dent like knuckles (green box) was clearly made by the extra large fragment still attached to the rebars, when they tried to bend past 90° (and recall the other side managed to bend over 130° the other way).

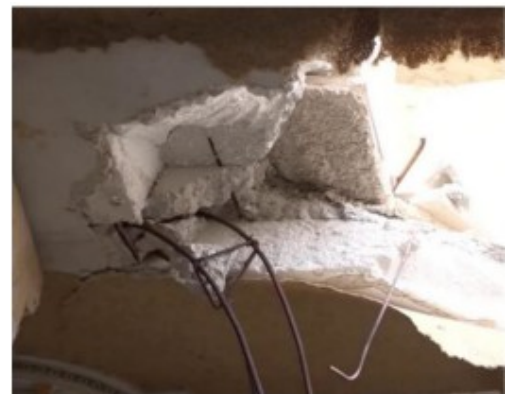
The FFM's expert modeled the initial impact at 60 m/s, slowed to 15 m/s after passing through the roof.<sup>65</sup> However, Michael Kobs challenges this in his 2025 report. With his engineering background and computer simulations, he found that for a 280kg cylinder with a kinetic energy of 504 kJ (kilojoules), the force required to slow it as the FFM proposed would be 900 kilonewtons (kN). Kobs estimates the roof as 20 cm thick including a layer of insulating foam, with an unusually weak concrete material like “gypsum or chalk” in a light rebar frame (right). He gives this roof an “optimistic” resistance of 30 kN, just 3.3% of that assumed in the FFM study. Kobs finds that this would barely slow the cylinder at all (from 60 m/s to 57 or 58 m/s), leaving it to punch through the floor as well. These calculations are open to question, but unless they're off by a factor of 30, Kobs' conclusion stands: the FFM modeling “must therefore have assumed an

unrealistically high ductile plastic energy absorption — i.e. the roof behaves like a thick metal buffer in the simulation, not like real masonry." <sup>66</sup>

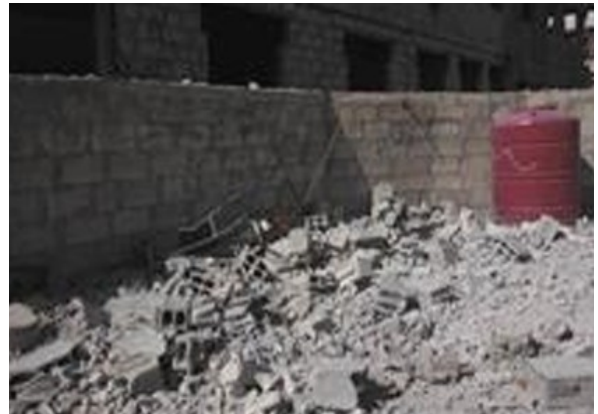
Considering the hole shape, and some clues the cylinder had a different route of arrival (see below), it was probably not dropped in from any height. It could be that what punched a hexagonal hole in the top of L4 was something else, sufficiently heavy and compact, falling from the same roof. A large volume of masonry debris surrounds the roof crater, mostly being hollow bricks, but with at least some heavier reinforced concrete (see right). <sup>69</sup> OPCW investigations don't mention this pile of rubble which, they think, the cylinder happened to land in the middle of.

A figure in the IIT report shows extensive damage to the taller adjacent building, notably of the roof-level “parapet” directly above this spot, with exposed rebar visible extending towards L4. <sup>70</sup> According to Google Earth satellite views, this damage was incurred back in 2012 (first clearly visible by February 2013), during fighting that left insurgents in control of Douma. A heavy portion of this debris could be what caused the roof hole. If so (satellite views are unclear), then it existed for over five years before the alleged chlorine attack.

All the visible rebar here appears quite rusty, even staining the concrete (image: IIT report). <sup>71</sup> Only normal weathering would play in here; hardly any chlorine would rise as high as the ceiling. The steel in the debris appears worse off than the building's own. This could show years of exposure with the hole covered over. However, rebar can be rusty to start with, so it remains *possible* the hole is just 18 days old as alleged.

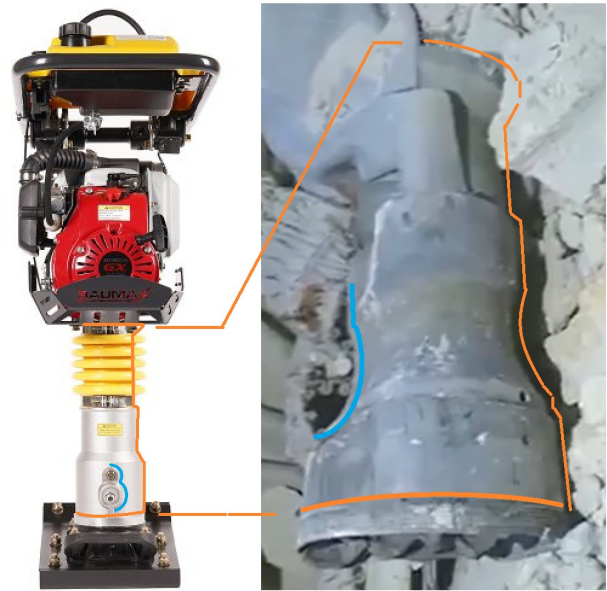
While no major building debris was seen in the room, it could have been there until someone removed it. One mysterious item (right) was seen clearly in a Russian news video by the curtains directly beneath the crater <sup>72</sup> and was apparently removed prior to the FFM site visits (not mentioned in their reports or visible in their photos). As Michael Kobs found, it looks just like the main piston of an upright concrete packer (although a different style than the example shown at right) <sup>73</sup> Such a tool might be used to compact new concrete slabs in the neighboring building, and be left on the roof until a blast knocked it off along with the visible debris. The motor portion and packing plate would have been removed, while this piston was left at the scene. The size and weight of this possible machine are unclear, but probably smaller and lighter than the blamed cylinder. Depending on the roof's actual strength, this could be capable of punching through or assisting in that, or it might just go to show how the hole was likely caused by debris from a place under construction, as the taller adjacent building was.

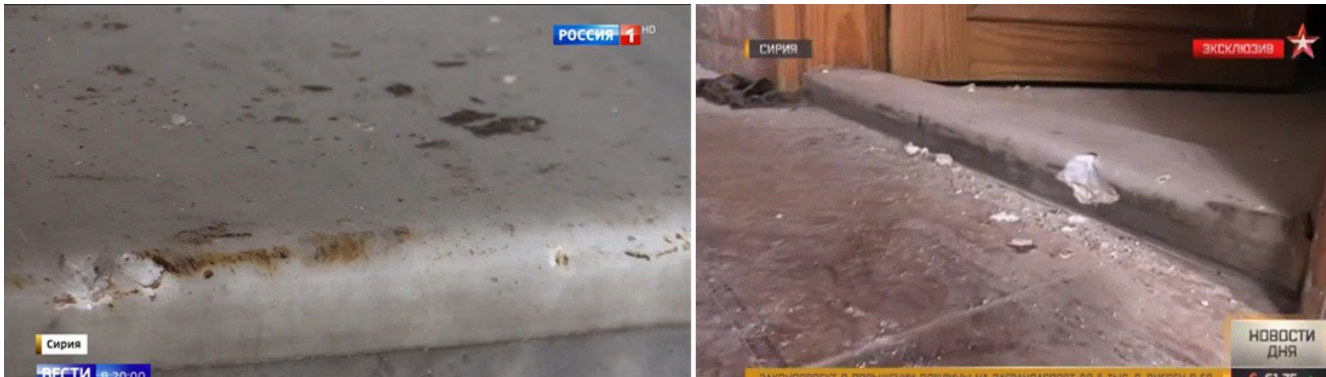
The IIT's experts would say this bounce onto the bed unassisted was "conceivable,"<sup>88</sup> and that its getting there "without human intervention" was "possible."<sup>89</sup> Implicitly but not explicitly, they also felt the cylinder getting there *with* human intervention was quite possible, even as they vigorously lobbied against that possibility. But they would say this possible scene manipulation would only follow on the cylinder crashing through the roof; they doubt that the "heavy and cumbersome" object was first "carried up several flights of stairs" and "through narrow corridors."<sup>90</sup> Open-source investigators Bellingcat would concur, saying this cylinder was quite a "bulky object to get up the stairs and through the door, apparently without leaving any obvious marks."<sup>91</sup> The lower fins might scrape some stairs on the way up, for example, or the handlers might drop the cylinder trying to squeeze through the

doorway, chipping the concrete doorjamb. In fact, two post-attack Russian News videos show signs of exactly these things (below).<sup>92</sup> This damage could have other causes, but it does exist. It's unclear if Bellingcat found these marks not “obvious” enough, ignored them as “Russian disinformation” or were simply unaware of this open-source evidence.

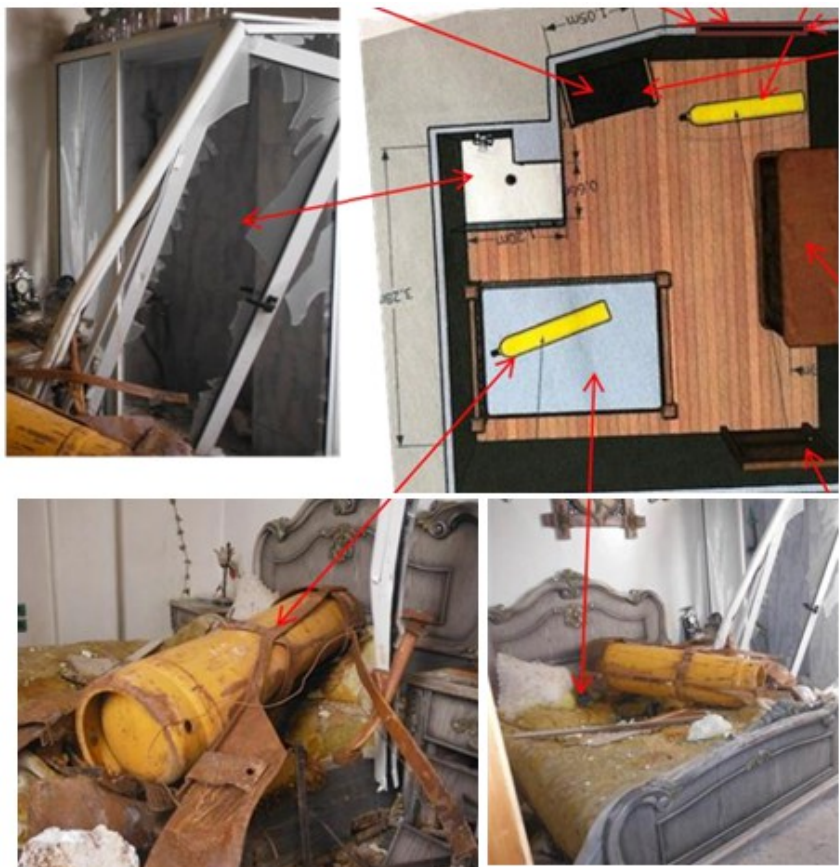
A shower next to the bed had its glass door smashed into by this loose member (right, cropped from FFM final.)<sup>93</sup> The EST report noted the door “appeared to have been pulled outwards” or “primarily in the west (“left”) direction,” rather than “forwards in the direction of cylinder travel” assumed in the FFM report.<sup>94</sup> That makes little sense as the result of the assumed trajectory. But in a manual staging scenario, one handler might stumble into the shower with the heavy cylinder, having the splayed-out wheels smash into and get tangled in the door frame. Then – especially if the handlers were cut by the broken glass – they might hastily yank it out onto the bed, just hoping it looked plausible enough.

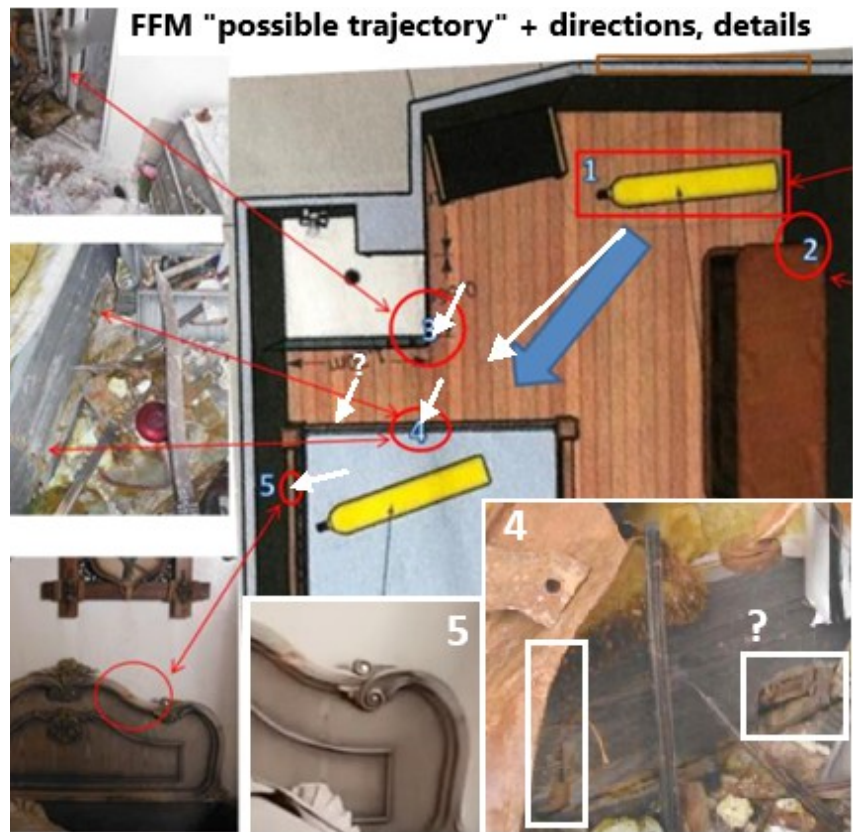
The handlers also might have stumbled forward at this time, smashing the cylinder into the bed's headboard. A dented scrape along the top edge is noted as the final point 5 on the FFM's "possible trajectory of the cylinder inside the room," shown at right with additions.<sup>95</sup> (Inset better view from Kobs report.)<sup>96</sup> Coming after its supposed impact 3 with the shower, this movement seems to deny the more sideways movement away from that and onto the bed evidenced by the broken door frame. But their same "possible trajectory" also includes as point 4 a rather sharp and vertical linear

gouge into the bed's wooden lower frame, right across from the shower (inset IIT),<sup>97</sup> along with other possible damage further along the base that's less clear and could hardly make sense.

The badly bent lower fin – and nothing else on the cylinder – might have a roughly vertical edge to cause this gouge, if there were a primarily leftward movement, which is already evident. Red boxes at right compare the gouge and that fin's edge. (IIT fig. 47). The cylinder would have to pivot almost sideways upon the shower mishap, with the rear end dropping low and swinging left and its front end pivoting up and into the shower (the glass on that side is also broken out). This is not modeled out or certain, but it's unclear what else could have caused the gouge, and it's impossible the same fin could, on the assumed trajectory, wind up on the bed rotated underneath, a bit above, to the left, and slightly *behind* this gouge. One way or another, this "possible trajectory" seems to have too many directions to it. Some awkward "human intervention" is by far the better explanation.

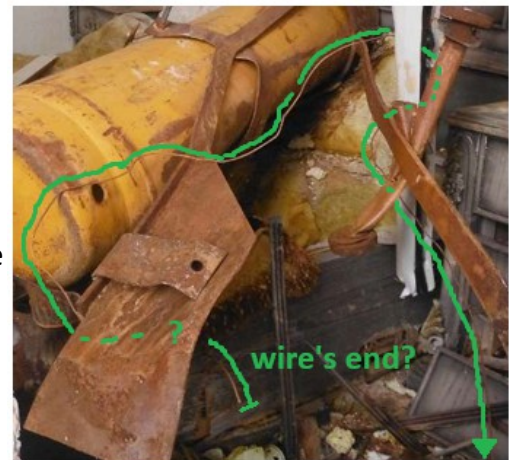
The IIT report's figure 47 (top view) may show that end of the wire on the left, with no sharp bend at the end to help secure it, but 2 more mild bends suggested. The loop over the wheel axle is seen more fully, suggesting a compound S curve there, and then a long straight span – as if to run back down the cylinder's length – extending off-frame. The FFM report's figure 14 (bottom view) shows the cylinder after being rolled over, with the S-shaped tweak around the axle plain as day, and the long straight span again extending off-frame.<sup>99</sup>

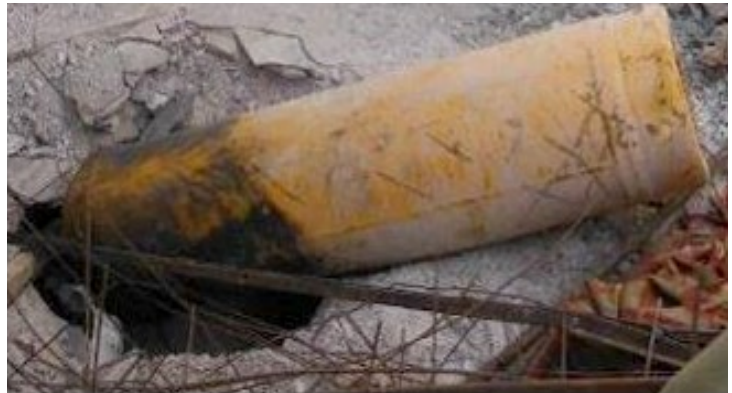
A framed mesh of thin, crossing bars, with attached scraps of cloth, was seen next to the crater. This likely covered the balcony as a canopy, and the FFM suspected the falling cylinder impacted it in that sate. Showing the image at right, they explained: “The visual damage on the body of the cylinder indicates that the lateral aspect of the cylinder did not slide on the mesh but it hit perpendicularly,”

somehow creating a crisscross imprint on the side.<sup>100</sup> The later IIT report would cite this “grid pattern corresponding to the metal mesh” as “consistent with the cylinder having hit the mesh at a considerable velocity, which in turn, would be at odds with the cylinder having been manually placed on the rooftop.”<sup>101</sup> Note the visible mesh has loose bars sticking out along the edge with regular spacing.

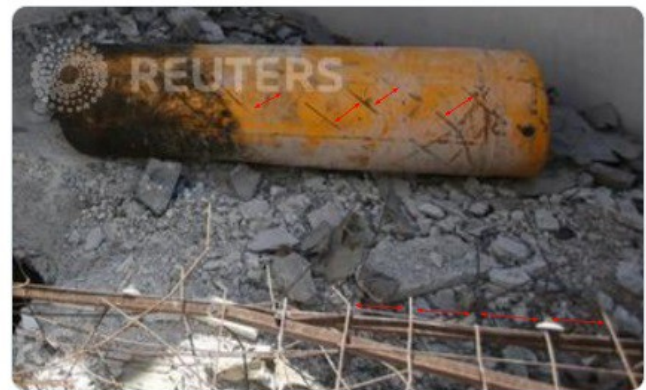
Replying to @MichaKobs @Deus\_Abscondis and 12 others

I think the best explanation for the diagonal scratches is not some kind of corset or heli-drop but some kind of pulling it over the fence.

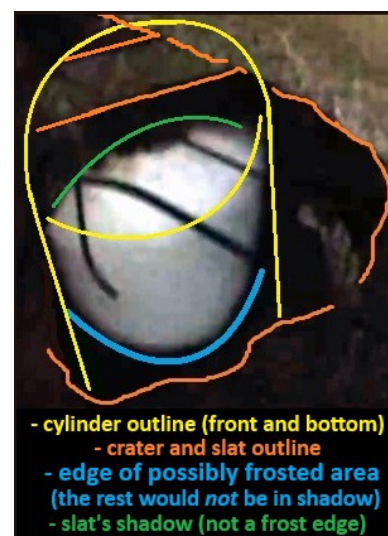
Although they remain debated, there are also indicators in the visual record of gas release at both sites. First, the underside of the cylinder at L2 appears strangely white in a video filmed just after 10 PM (about 2.5 hours after the alleged attack). This was mentioned in the IIT report <sup>120</sup> – after the FFM reports had ignored the point <sup>121</sup> – as a likely coating of frost suggesting gas release. This would cause auto-refrigeration of the effectively liquid compressed gas, so that metal in contact becomes freezing cold. The author cannot disagree on that point, and notes how the potentially frosted area has a visible edge (blue curve), suggesting that only around 1/3 of the bottom is frosted. That would mean that a

majority of the content has already expanded to gas, most of that after a rapid initial release as a swiftly-evaporating liquid.

The L2 valve was hidden in shadow for the above view, and it was snapped off by the time anyone saw it clearly, maybe right away as the method of staging a gas release, or later on to hide another method. A fire was deliberately set in the corner of the room beneath the cylinder, coating the walls, ceiling and the exposed underside of the cylinder with heavy black soot. This FFM heard this was done hoping to detoxify the room,<sup>122</sup> but perhaps it was meant to do the opposite and “toxify” the scene. The valve should have a soft metal fusible plug set in the side that would melt away and release the compressed gas after just a mild fire (to prevent explosions).<sup>123</sup> The soot is all there in the video with the possible frost coating.<sup>124</sup> The obvious soot is *not* “a dark compound” that’s metal-related but forms atop the yellow paint and that proves chlorine release, as argued in the Emmy-winning New York Times video report.<sup>125</sup> But it *is* hard to see how a yellow cylinder *coated in black soot* could possibly appear so white, except with a layer of frost covering it.<sup>126</sup>

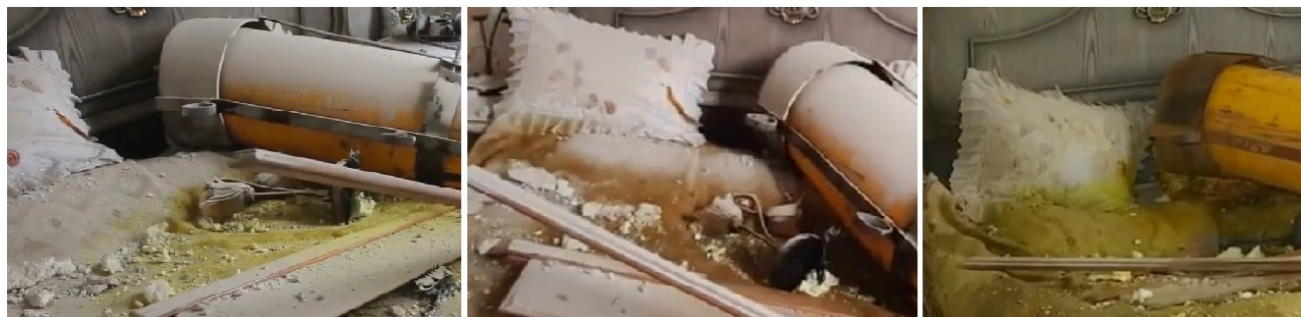
Sequential images over 17 days (video times via Kobs<sup>135</sup>) are read by the author as showing:

- 1) April 8, ~10 am: the white bedspread has its lower points and debris coated in dense gas and/or somehow stained that color, as a red-brown trail and spots appear on the white pillow.
- 2) April 8, ~4 pm: around 6 hours later, the staining is now definite and coats the entire bed, minus perhaps the highest points, but is somehow *a mild reddish brown color*.
- 3) April 25, as the FFM visited, there is new yellow-green staining atop the brown and even on the pillow, as from another release (the bed has also collapsed by then).

To pile as deeply as those images suggest probably requires a lot of gas released quickly, and for less than half the contents to be used in these weeks, little to no gas escaped in between these episodes. This kind of emptying would be slow on balance, but not at all “steady.” And the most logical single explanation for all of the colors we see would be: the staining happens first in a chlorine color, and this shifts to brown over the span of a few hours. Green appearing twice would then mean there were at least two distinct episodes of release.

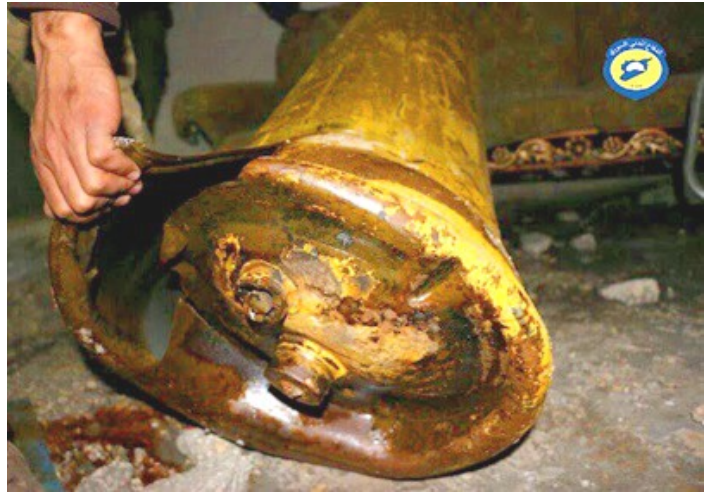
A viscous red-brown residue at L4 has also appeared with previous alleged chlorine attacks, like the 2017 incident in Al-Lataminah cited in section 2.2 (enhanced photo at right). It seems the spilled majority of liquid pooled in the dark brown spot on the floor (and likely off-frame) before it vaporized. But a thinner brown residue also coats the painted exterior of the cylinder (mostly *above* the rupture) and, it seems, across the floor, as if it were floated there in the gas cloud. This image also includes

an upholstered couch that sports green and gold by design, along with red-brown patches that could also be part of the design or added by the gas. (In a sudden and total release in a small space, a deep cloud would form, most likely enveloping the cylinder and couch entirely.)

As to why chlorine would leave a brown residue, one source explains "chlorine gas can also react with iron to produce iron (II) chloride and iron (III) chloride." The former isn't described, but the latter "is characterized by its red-brown color and its ability to dissolve in water, forming a yellow-orange solution due to the presence of iron (III) ions."<sup>138</sup> Both colors are widely evident on the L4 bed. In the FFM photo at right (natural color), the bedding materials appear yellow-orange with brown crust.<sup>139</sup> Iron (III) chloride (or  $\text{FeCl}_3$ ) may be what we see, presumably from iron in the steel cylinder and its steel harness reacting with the abundant chlorine, seemingly worsened with water repeatedly splashed over the scene (for no obvious reason).

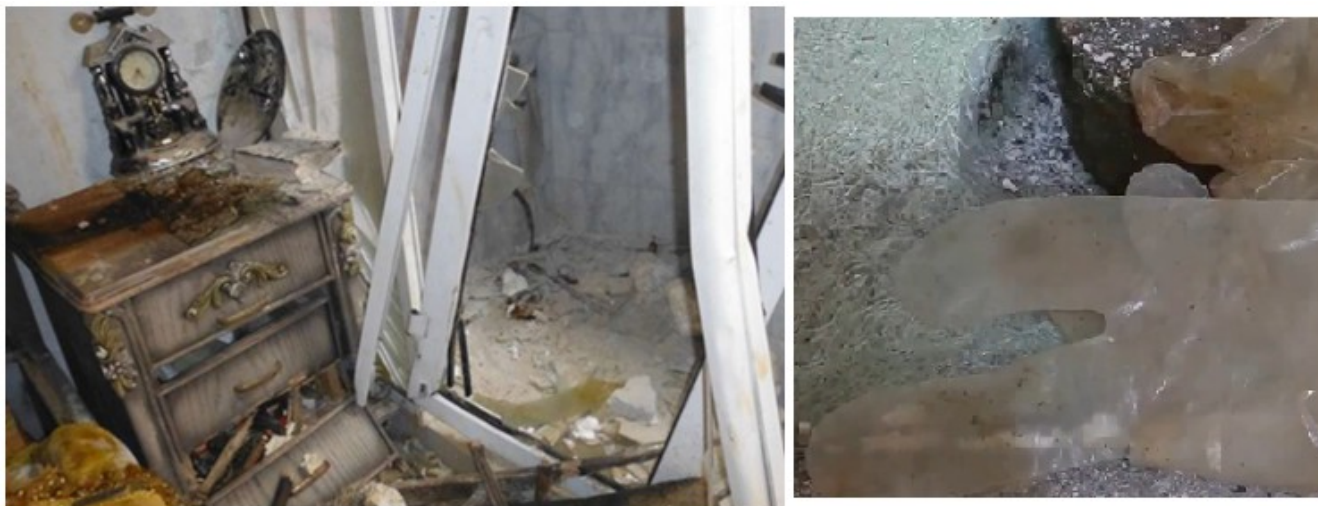
The brown goo was ubiquitous. “The FFM team observed a viscous liquid throughout the room, which was not apparent in videos.” <sup>145</sup> They did not describe its color, but it's reddish-brown. Just one photo in the IIT report (below, left) shows this in the run-down of water splashed on the wall, in a thick puddle on the bedside cabinet, and in a tacky residue on the broken shower door (glass and frame). <sup>146</sup> The FFM further noted how “The same liquid was observed also before the entrance to the apartment

and on disposable gloves present at the location.”<sup>147</sup> Some gloves seen in a Russian news video (below right, via Kobs) are most likely either the same ones, or others used for the same task, and it seems the task involved a reddish-brown viscous fluid. The residue on the gloves was tested by the FFM and found to include 17,000 ppm of combined chlorides, and 1,500 ppm of zinc.<sup>148</sup> More zinc might be expected if these were used to manage the valve, but either way, it seems the valve was managed.

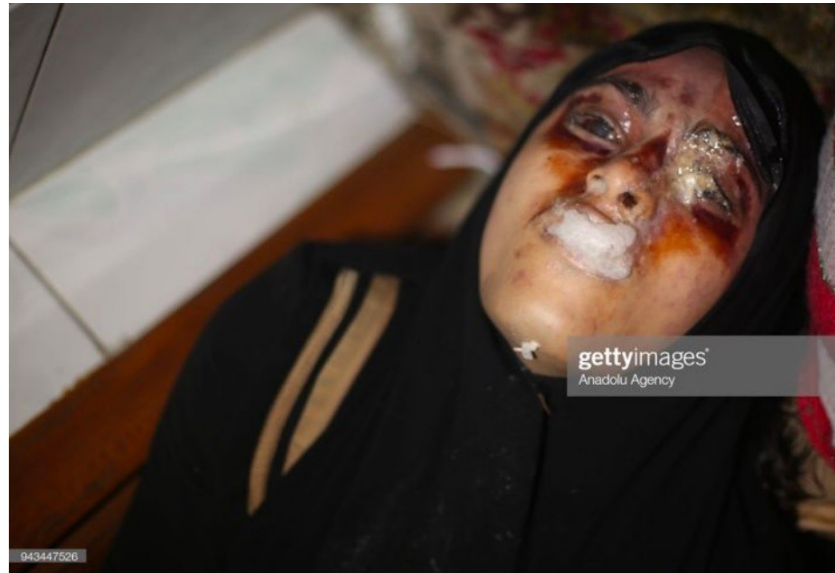
A) W7 vivid mask pattern – rotated view nearly upside-down – natural color. <sup>228</sup>

And for this fluid to be slowed down at the upper cheeks for longer contact and deeper effect – while somehow avoiding the eyes – almost requires all of the above plus protruding objects with the shape and effect of goggles, as already shown above. With W7 (mask pattern turned upside-down at right), the possible goggles seem to be abnormally secured with straps across the cheeks, with a crossing at the bridge of her nose that also slowed the fluid, and it seems her hijab was secured by these straps, causing some slowdown before her protected forehead. Others like B6 and G6 suggest no such straps, instead having additional clear patches, perhaps from a wad of adhesive material set in the middle of the lower rim, and likely on the top rim as well (the flow pattern there is less clear). The usual connection across the nose is suggested by increased fluid effect there in several cases. The usual side-straps of the goggles were likely used as well, but if so they don't seem to have effected the flow around the outer rims.

As noted above, W7's exceptionally dark pattern is likely due to her unusual body position as seen at L2 – laid on her back with her face upside down, as proposed to initially cause this pattern. The early flow would leave the most vivid effect, formed over probably 1-2 hours or less while the goggles were

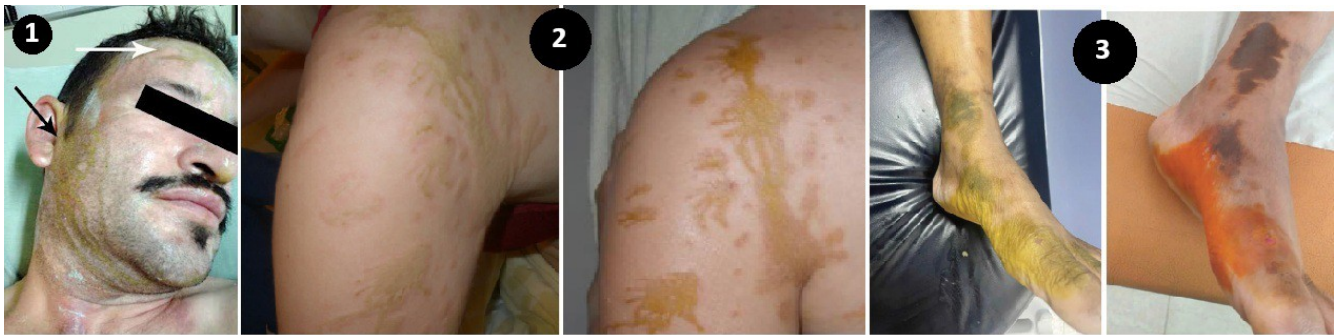
C) XP reaction examples

The XP reaction is most commonly seen in humans with accidental exposure to liquid NA, which has various industrial uses. One article with images relates a victim splashed in the face in a deliberate assault (see Image C, panel 1 on p.50). Golden yellow stains are seen where the liquid ran down his cheek, with mild redness along the edges and worse on his neck, and pale brown staining of the scalp and forehead. <sup>214</sup> Another article relates several cases of accidental exposure to liquid NA with photos showing "Ila-b chemical burn on day 1 with relatively pale staining" vs. "intensified yellow-brown staining" seen on day 2. A shoulder is shown with small liquid splashes shaped by clothing seams, all of it darkening to orange-brown in the second image (Image C, panel 2). <sup>215</sup> This is from brief exposure with early treatment, slowing the effect. Another visual case of the XP reaction is more advanced, yellow NA burns on a man's foot have turned bright orange 24 hours later, with greenish areas turning dark brown. Both areas seem to show more underlying skin and thus more redness than usual. After delayed treatment, his burns were assessed between stage II and stage III. (Image C, panel 3) <sup>216</sup>

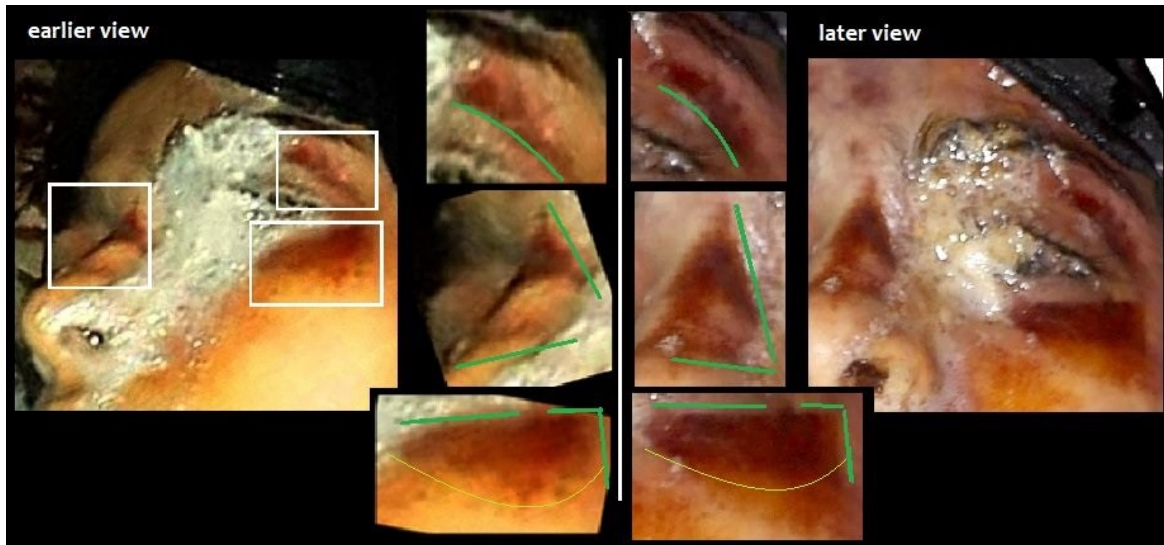
D) W7 progression. Left: early photo, color-enhanced. Right: early morning, natural color.
